Walk & Talk Notes

Client: Greenspace – The Cambria Land Trust

Site: Strawberry Canyon, Cambria

Site Visit Date: December 9th, 2024

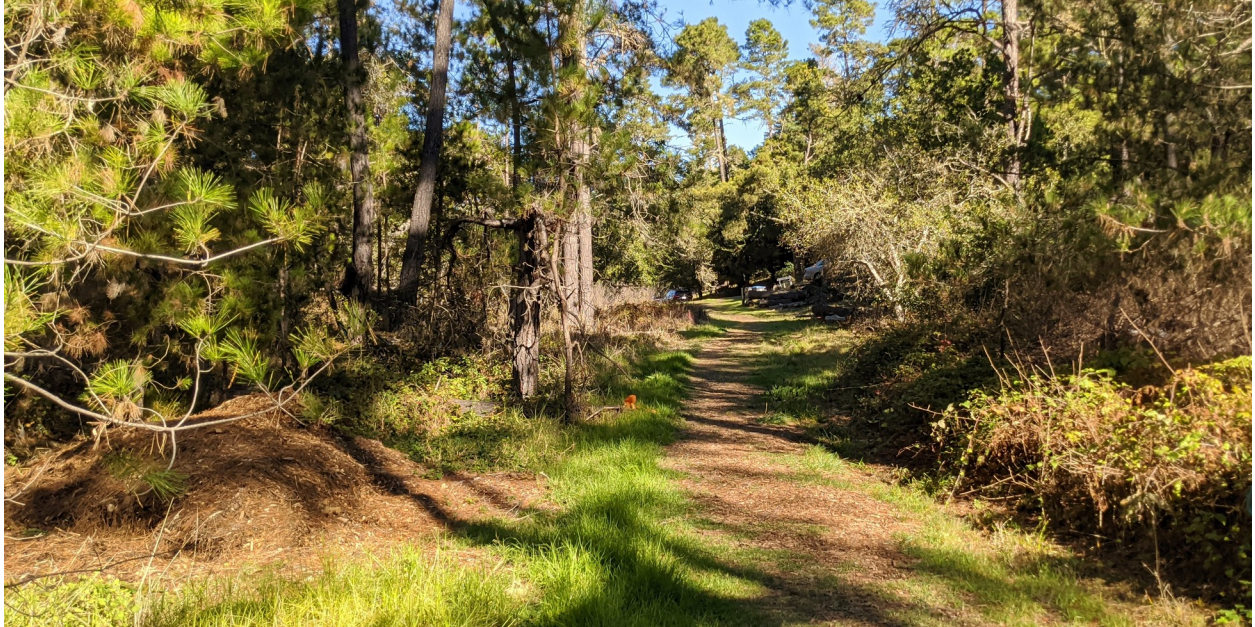
Figure 1: The utility road bisecting the broad and gently-sloped valley bottom at the top of the property, with the saddle/entrance to the property at the intersection of Burton and Kay streets in the background. Photo taken from highest access route drainage crossing on property.

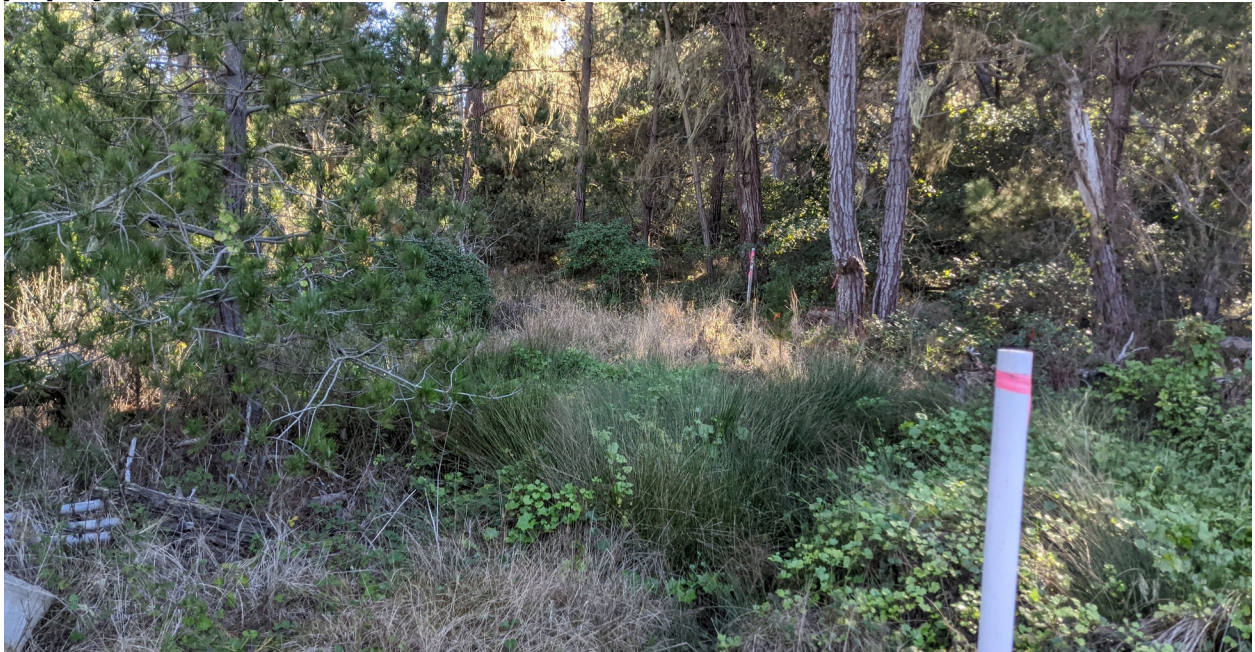
Figure 2: The relatively broad and gently-sloped drainage channel at the lowest point on the property. Photo taken from the intersection of Benson and Randall Streets.

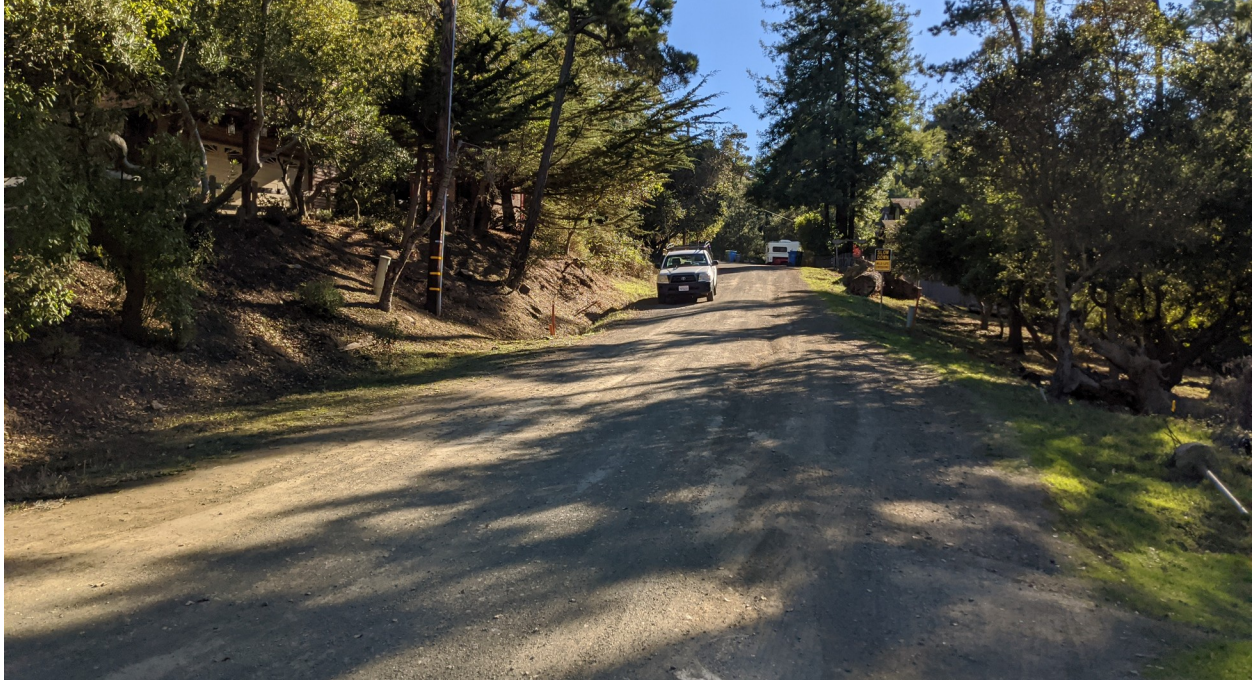
Some of the surface runoff that drains into Strawberry Canyon is collected on the saddle/Kay Street, but the majority of the surface runoff entering the property is collected on the roofs, hardscapes, and softscapes of the residences located on the western half of Lodge Hill. Much of this runoff drains onto Burton St, where it is funneled by curbs and allowed to gather volume and speed over long distances until it reaches two main culverts.

Figure 3: The uphill portion of Burton Road that drains into Strawberry Canyon. Photo taken from the Burton/Kay entrance to the property.

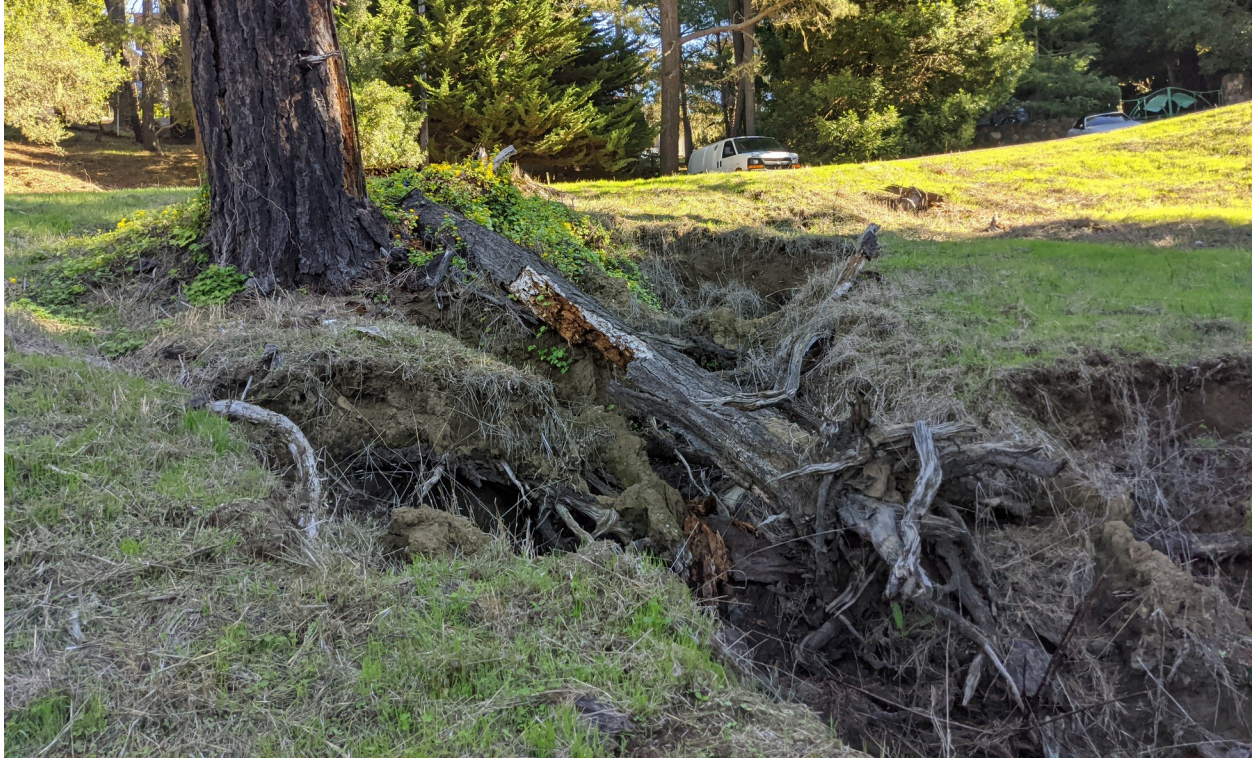
The first of these culverts drains onto a property not owned or managed by Greenspace, but which is uphill of and ultimately drains into the Strawberry Canyon Greenspace property. A massive headcut (erosive sheer drop in a drainage channel formed by fast-moving water) has developed just downslope of the culvert outlet. Its progress towards the culvert outlet has been temporarily arrested by a Monterey pine tree trunk, however it will eventually undermine the tree trunk and quickly erode the area uphill of it until it reaches the culvert outlet and ultimately undermines the western edge of Burton Drive.

Figure 4: The headcut in the drainage channel just below of the outlet of the highest-elevation culvert located on the portion of Burton Drive uphill of and that ultimately feeds onto the Greenspace Strawberry Canyon property. The progress of which has temporarily arrested by the dead pine tree trunk.

Within Strawberry Creek and its tributary drainages (especially the off-property one that the highest Burton culvert drains into, if at all possible), [rock-armored energy dissipation pools \(aka “Zuni Bowls”, which also serve as sediment deposition basins\)](#)⁷ should be installed in any active headcuts to mitigate further erosion while the eroded drainage channel becomes revegetated. Creek aggradation structures like [one-rock dams](#)⁸ and [beaver dam analogs](#)⁹ should be installed in steep sections that have experienced erosion. The local Natural Resources and Conservation Service (NRCS) is beginning to provide [grant funding](#)¹⁰ for the installation of such creek-restoring structures.

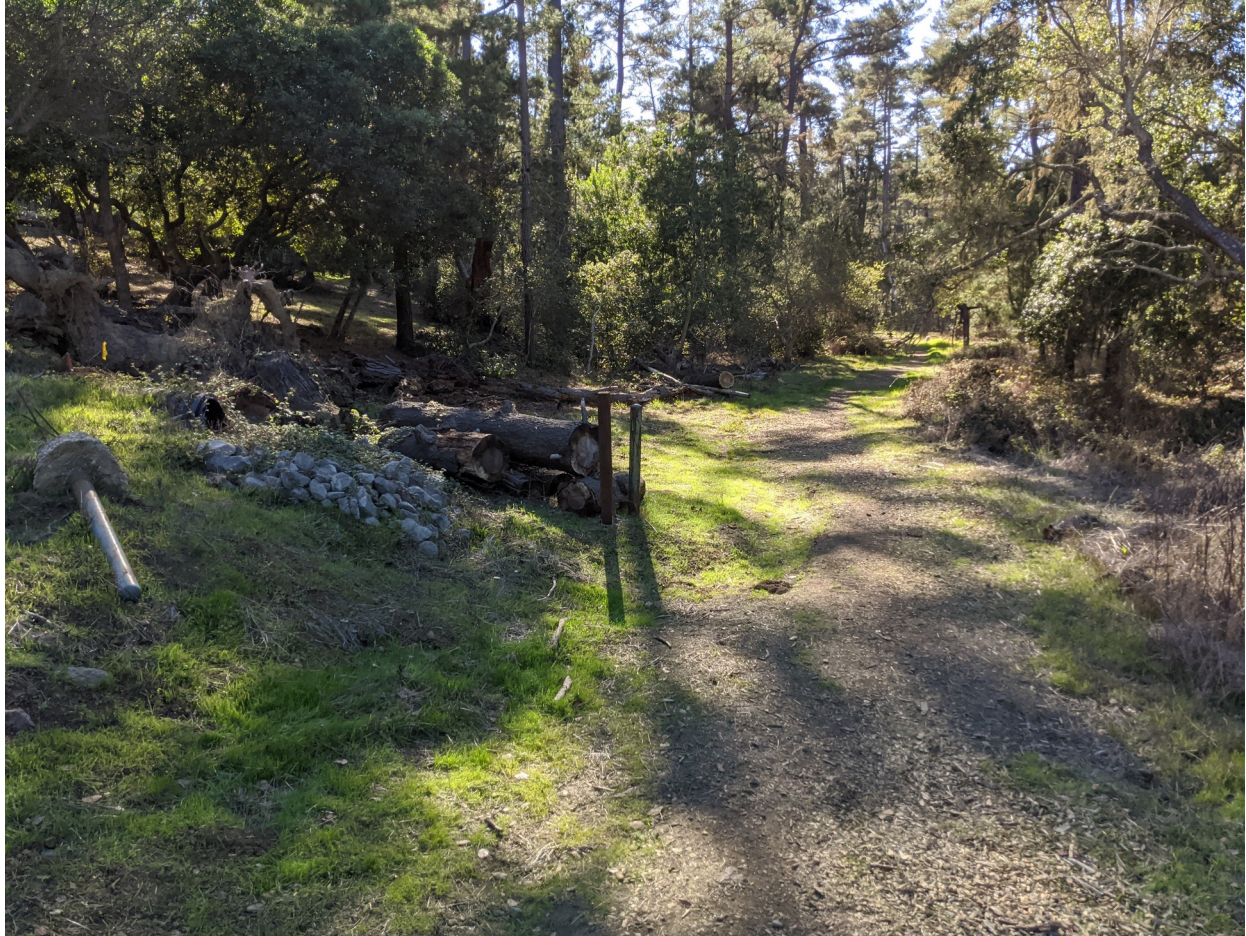
The second culvert uphill of the Greenspace Strawberry Canyon property and along Burton Drive is located just uphill of the entrance to the property at the intersection of Burton and Kay. This culvert drains into a small geologically-armored (rock) rundown just uphill of a utility access road which runs from Burton Street into the property directly downhill of the saddle. There is no sign of major erosion at this culvert outlet, however the water drained from it collects on the road (which has little to no slope at the entrance of the property, due to it originating from a saddle) and creates passability issues during rain events.

Figure 5: The outlet of second-highest culvert draining water across the portion of Burton Drive uphill of and that ultimately feeds onto the Greenspace Strawberry Canyon property. This culvert empties directly onto the Greenspace Strawberry Canyon property, where it pools on and drains down the utility access road shown. Photo taken from Burton Street.

The flooding at the Burton/Kay entrance to the property can be mitigated by relocating the outlet of the recently-installed culvert draining water to a location further downslope, or by installing an additional drain ([rolling dip](https://www.youtube.com/watch?v=PD-lRgtvxtY&list=PLJy8-1MQvUQzCQb1VI93BCPsTrj7rQ6pd&pp=iAQB)⁵ or culvert) across the utility access road and into an excavated drainage channel that is below the grade of the road down its entire length. [Geologically-armored sediment deposition basins \(which also serve as energy dissipation pools, aka “Zuni Bowls”\)](https://www.youtube.com/watch?v=PD-lRgtvxtY&list=PLJy8-1MQvUQzCQb1VI93BCPsTrj7rQ6pd&pp=iAQB)⁶ should be installed at any location in this drainage complex where the grade of the drainage channel becomes less steep (rolling dip/culvert outlets, etc) to facilitate the easy and regular removal of sediment from the system to eliminate potential clogs. If a new drainage channel is excavated alongside the utility access road at the top of the property, geological- and biological-armoring should be used in strategic locations and with very intentional placement to ensure that the drainage channel does not become erosive.

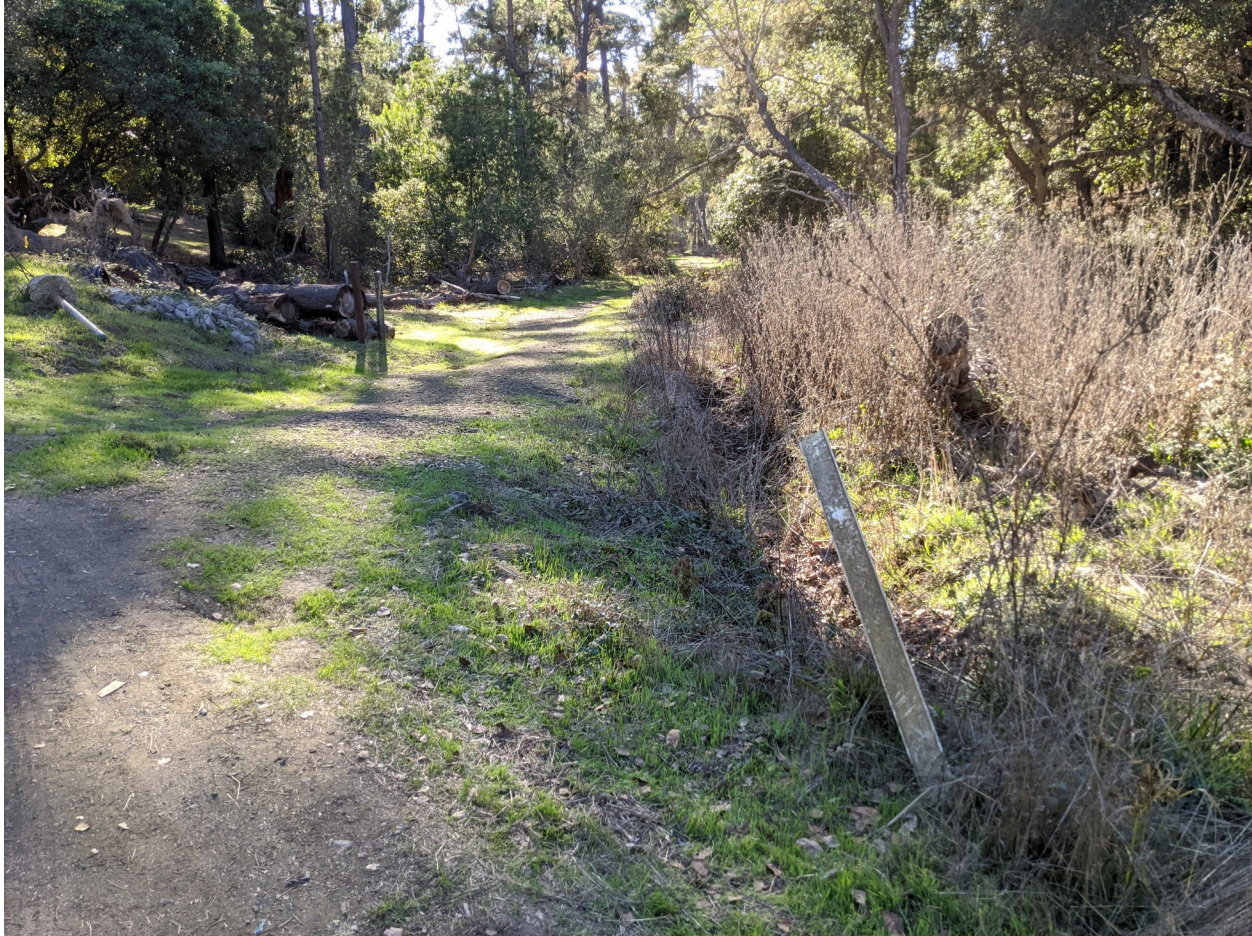
A third culvert draining onto the Greenspace Strawberry Canyon property is located at the same elevation as the Burton/Kay entrance to the Greenspace Strawberry Canyon property. This culvert drains what little water collects on the small area of the saddle uphill of the entrance across Burton. The outlet of this culvert is located just north of, alongside, and slightly lower in elevation than the utility access road that enters the property from Burton/Kay. The drain channel from this culvert outlet quickly meets the grade of the utility access road however, at which point the runoff also collects on the road and pools.

Figure 6: The outlet of the lowest culvert draining water from the saddle across Burton onto the Greenspace Strawberry Canyon property. The shallowness of the downslope drainage channel can be seen, along with the outlet of the uphill culvert and the utility access road between. Photo taken from Burton Drive.

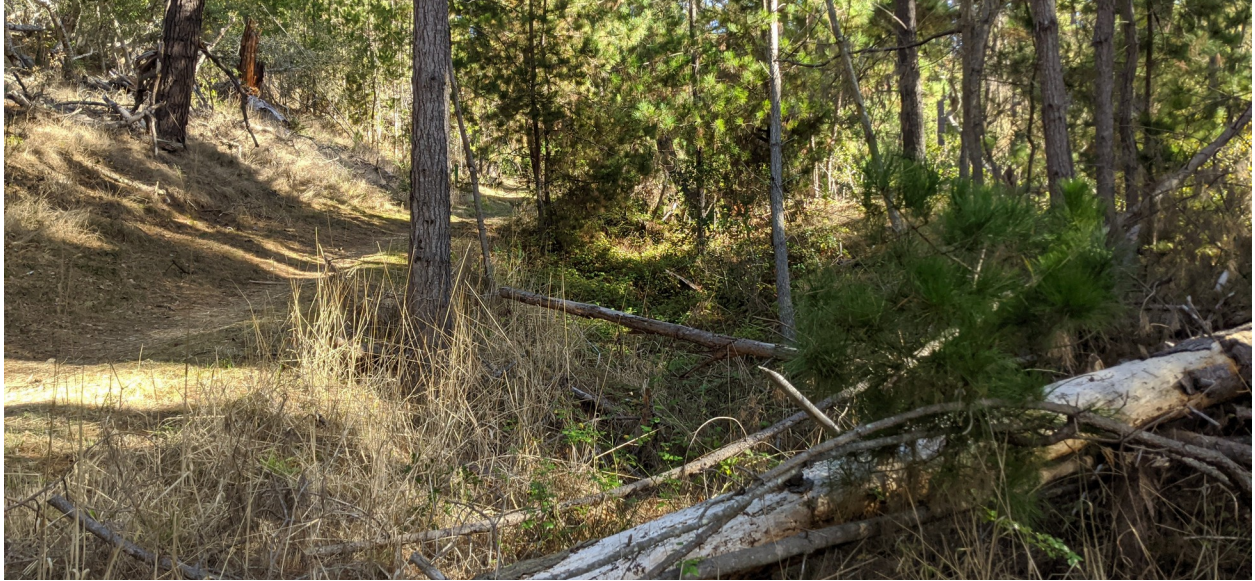
The main utility access road that runs through the property generally lies directly within the valley drainage channel (in the more gently-sloped, broad areas) or just uphill of it (in the more steeply-sloped narrow areas). Several trails also run along the drainage channel, and cross it in some areas. Valleys are an initially appealing place to install access routes as they are generally not very steep along their length or steep across their width, thus allowing for minimized earth-moving, but they prove problematic in the long term from an access, maintenance, and erosion-control standpoint if not designed with drainage in mind (or if they are installed directly within the drainage!). Access routes placed adjacent to or within valley bottoms act as “funnels” that concentrate and accelerate any water that runs onto them from uphill areas. Unless the access route is properly designed to account for drainage from the start (rare), the discharge of the concentrated and accelerated water from a valley access route often becomes erosive to both the road itself and the receiving drainage/creek alongside – and the rate of erosion increases year over year. This is true of the road alongside Sycamore Creek, which has a few areas where vehicle access is has an immediate risk of being lost due to steepening banks where the creek has become incised and adjacent headcutting, and several other areas that will be at risk within the next year or two if not rectified.

Figure 7: One of the main access routes on the property is located directly uphill of the drainage channel. This incised access route captures uphill runoff, which then increases in volume and speed until it ultimately enters the drainage. Erosion is evident along the road and in the drainage channel downslope.

The access routes which are serving as funnels for the runoff generated from the uphill areas should be designed at the same time as the water system, ideally with the same site-wide, holistic approach recommended for water above. The [design process](#)¹¹ should consider new and/or improved routes that follow the ridges or traverse the hillsides and cross valleys along contour. [Water should be drained from any existing or proposed new access routes as often as possible](#)¹², and always at “first chance” and “last chance” locations. Water [drainage elements that discharge runoff as shallow, non-erosive sheet flow](#)¹³ should be selected (like [rolling dips](#)¹⁴ or water bars), and they should discharge onto gently-sloped ridges, geologically-armored flow-spreading structures such as [“media lunas”](#)¹⁵, or into geologically-armored energy dissipation pools.

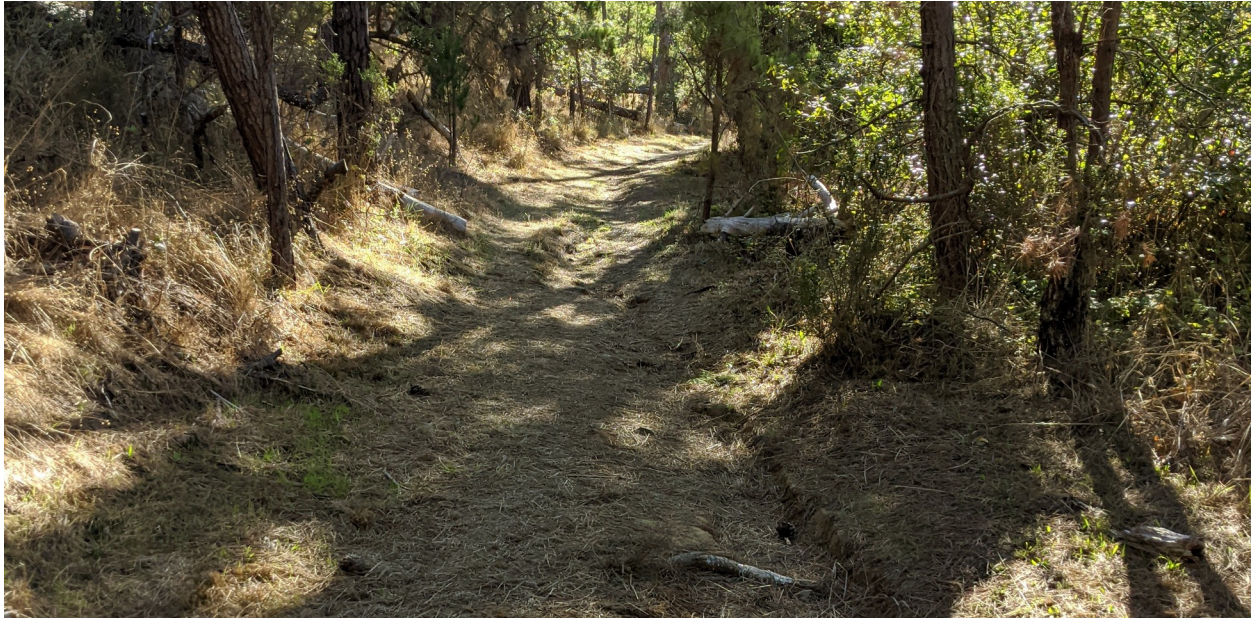
Figure 8: An eroding trail. The incised nature of the trail does not allow water to drain, but rather erosively funnels it to locations further downslope.

Any access routes selected for decommissioning should ideally be restored, however at the minimum simple drainage structures like water bars configured with media lunas should be installed along their lengths to prevent further erosion.
